River Fly- In Condominium
 Unit: 302

Framing

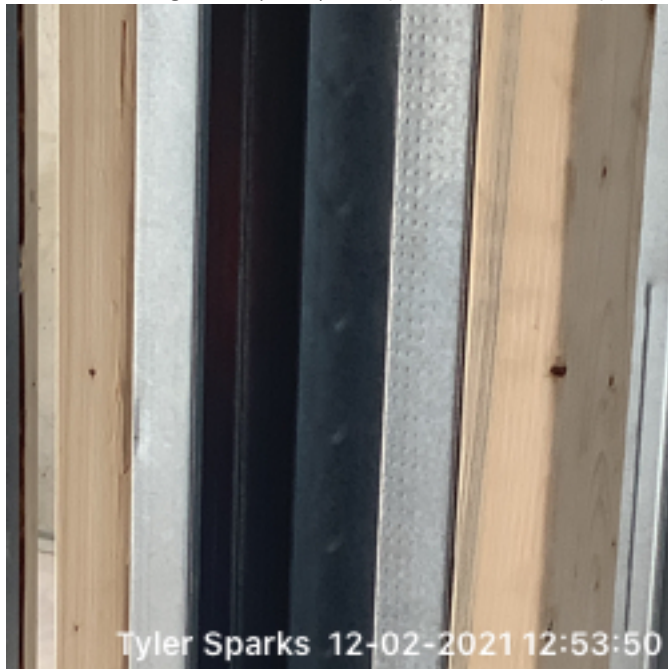
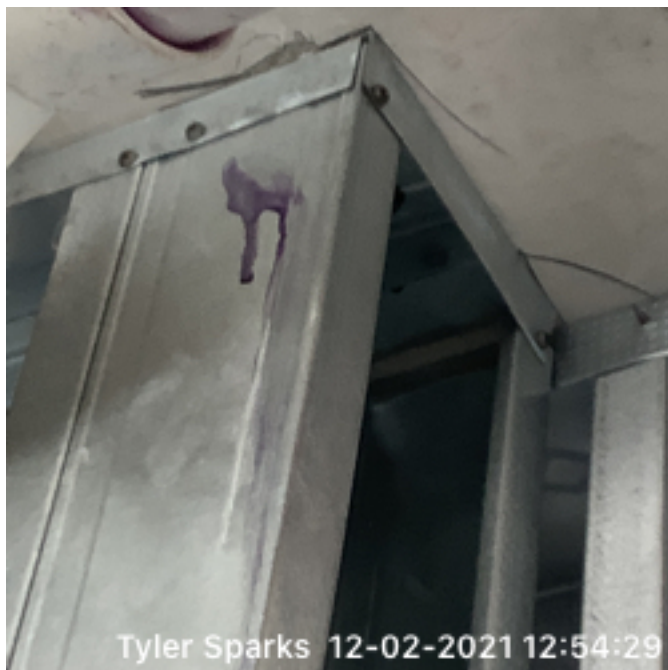
1.01-Post are correct size per plans/code.

S - Satisfactory, the system meets plan/code/manufactures specifications

NOTE: Post are correct size
