River Fly- In Condominium
 Unit: 510

Report By: Tyler Sparks

03/02/2022

Framing

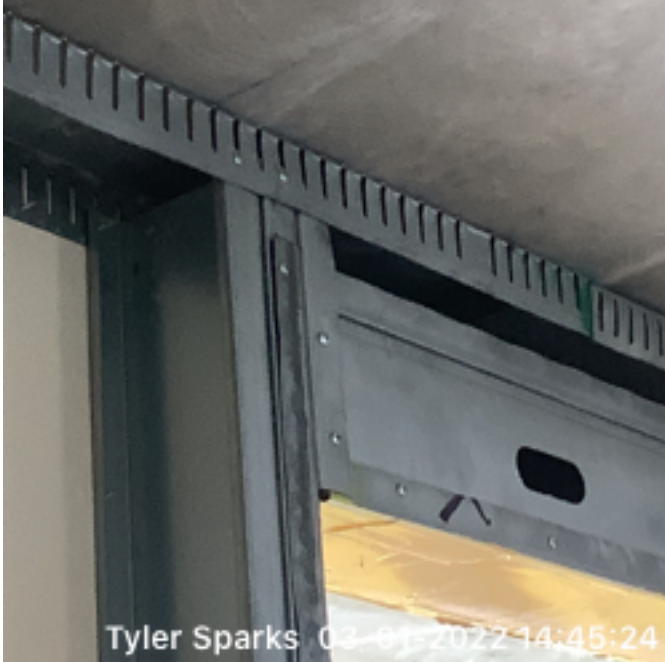
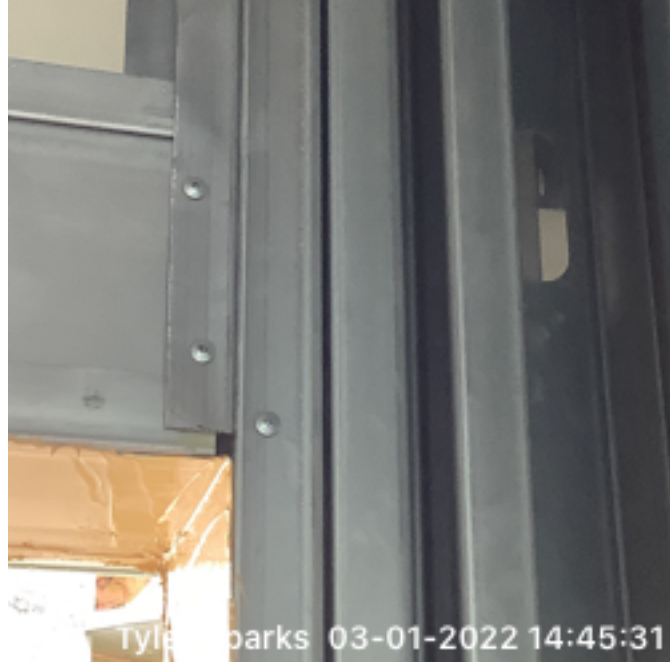
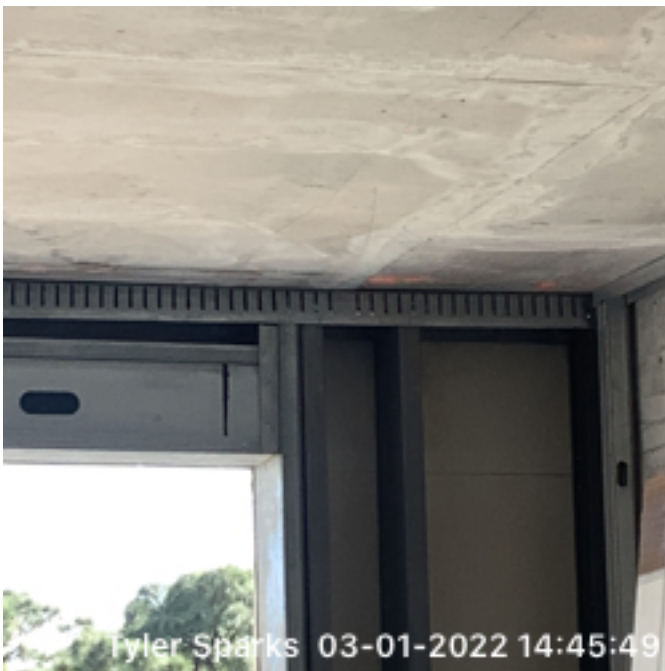
1.00-Beams and headers are correct size per plans/code.

S - Satisfactory, the system meets plan/code/manufactures specifications

NOTE: Beams and headers are installed per plan

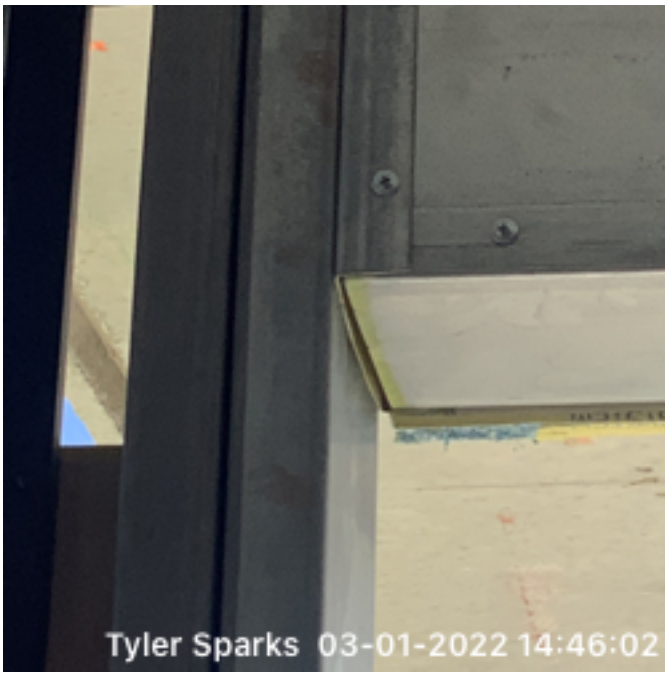
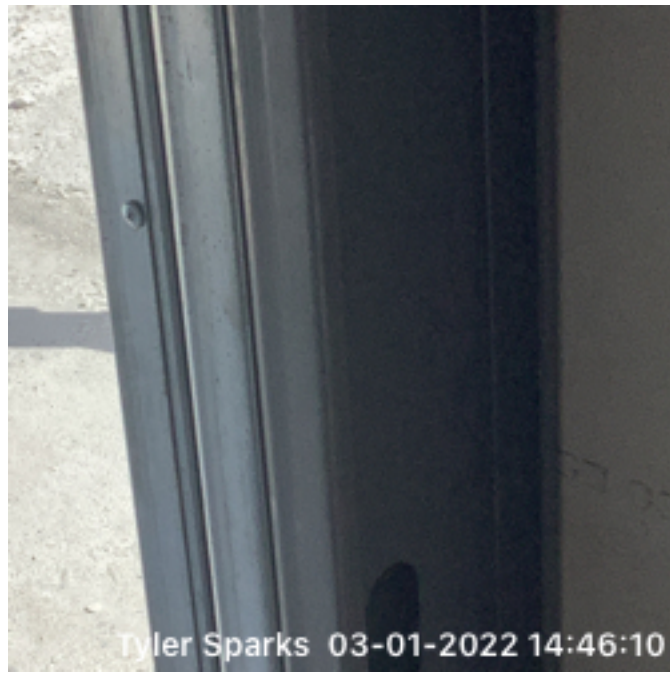
1.01-Post are correct size per plans/code.

S - Satisfactory, the system meets plan/code/manufactures specifications

NOTE: Post are correct size per plan

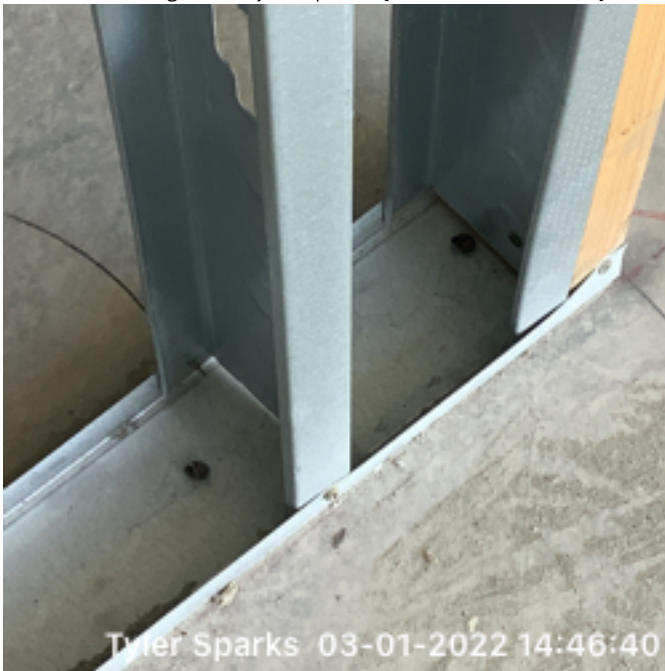
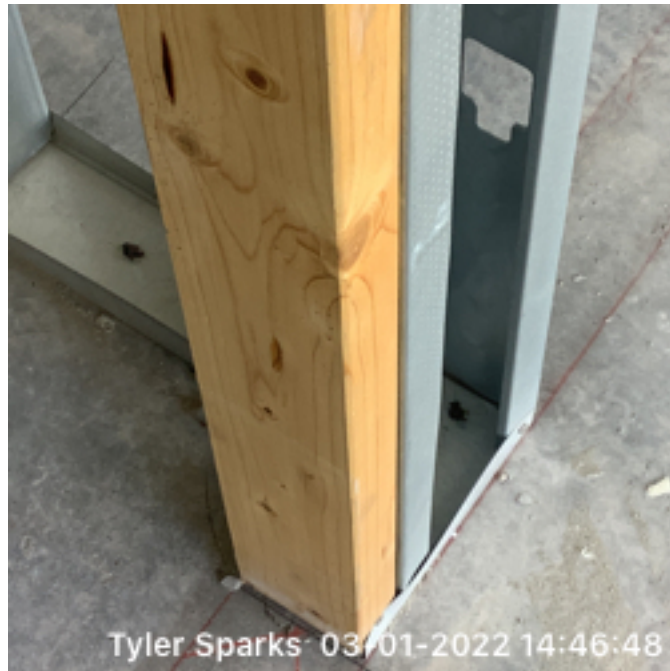
1.04-Anchor bolts are installed per plans/code.

S - Satisfactory, the system meets plan/code/manufactures specifications

NOTE: Pin shot

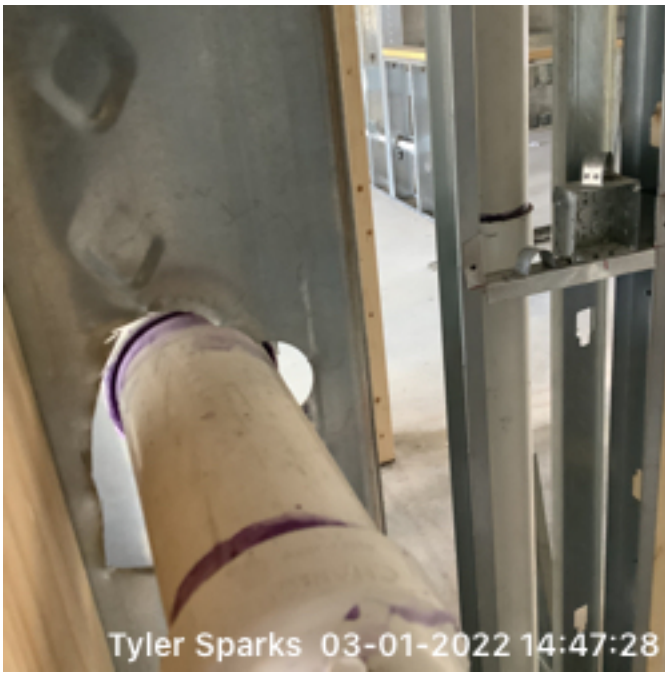
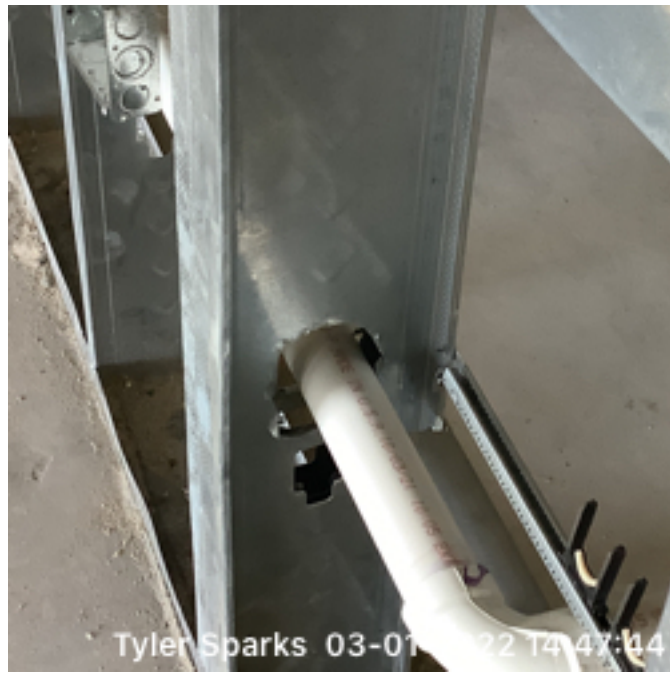
1.06-Wall framing components have not been over notched or drilled.

S - Satisfactory, the system meets plan/code/manufactures specifications

NOTE: Wall framing is not over drilled or notched

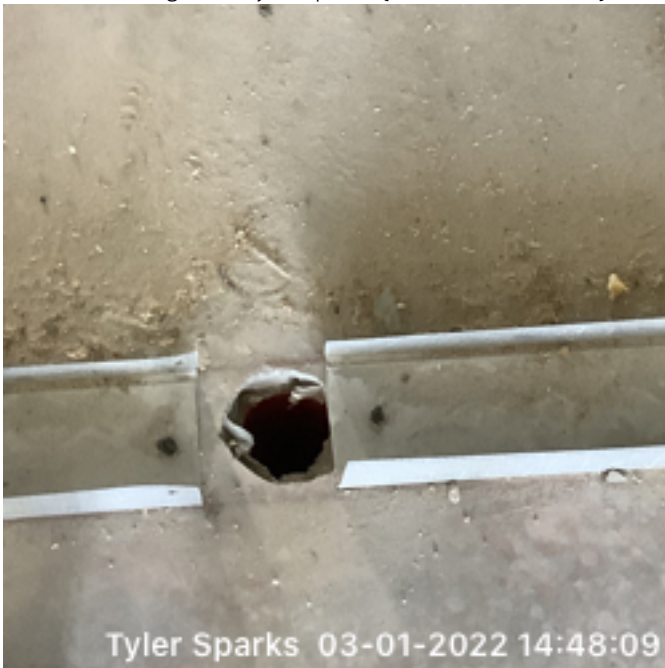
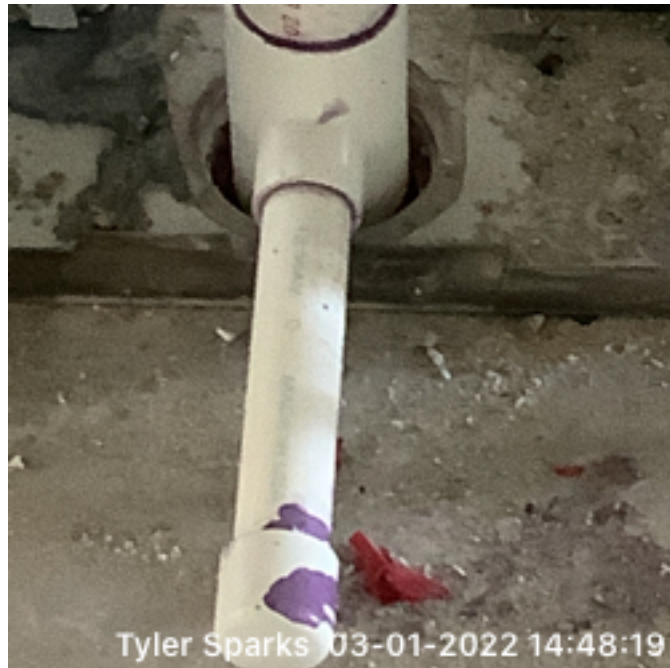
1.07-Floor framing components have not been over notched or drilled.

S - Satisfactory, the system meets plan/code/manufactures specifications

NOTE: Floor framing is not over notched or drilled

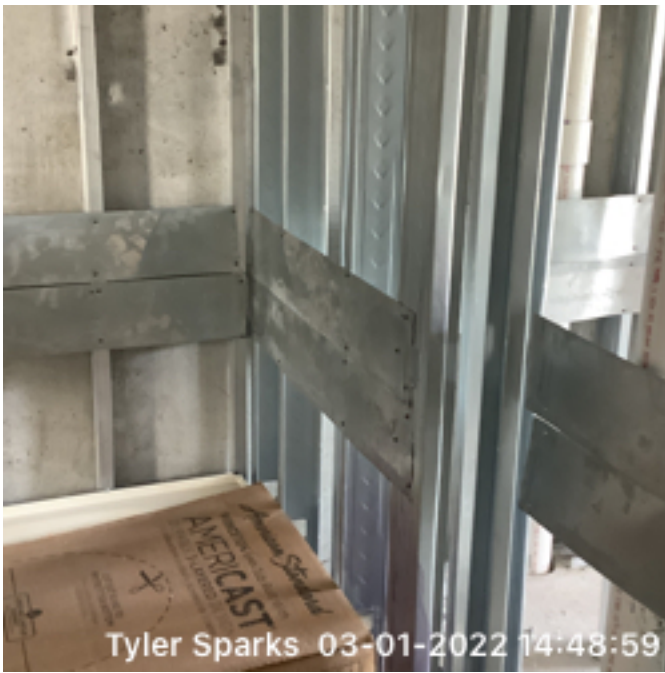
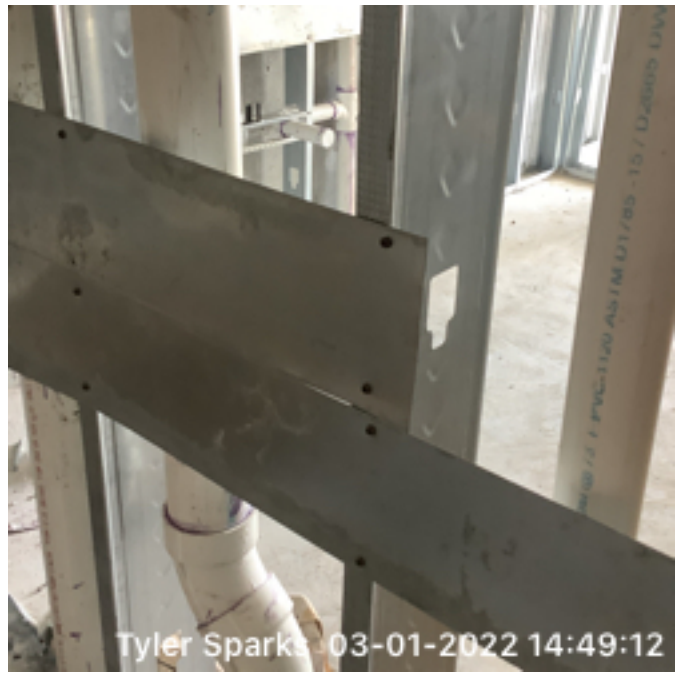
2.03-Interior backing has been installed for railing, plumbing and/or electrical items.

S - Satisfactory, the system meets plan/code/manufactures specifications

NOTE: Interior backing has been installed per plan
