River Fly- In Condominium
 Unit: 514

Report By: Tyler Sparks

03/02/2022

Framing

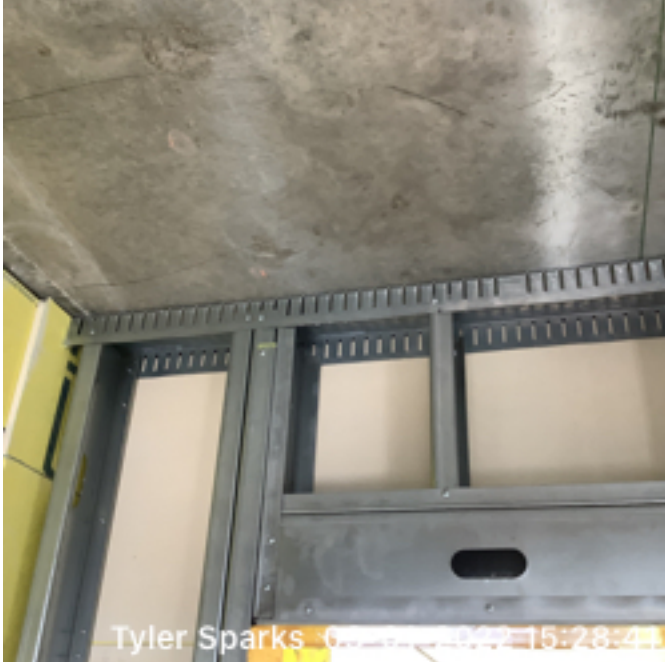
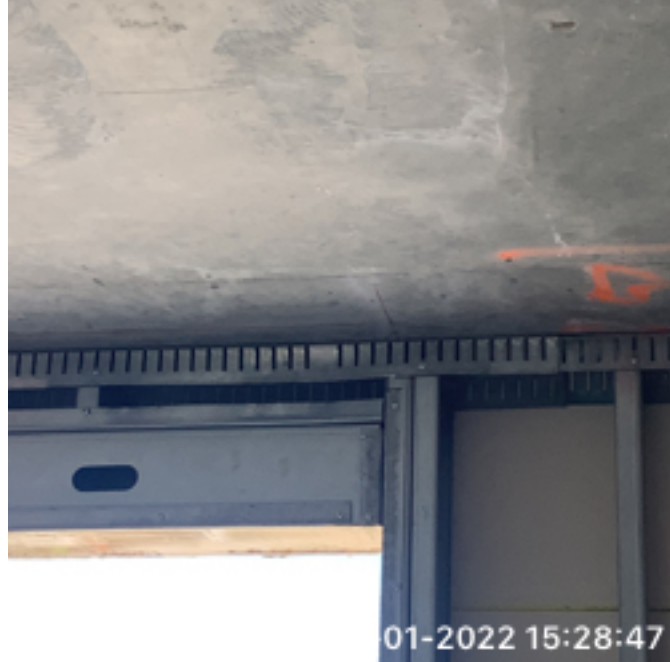
1.00-Beams and headers are correct size per plans/code.

S - Satisfactory, the system meets plan/code/manufactures specifications

NOTE: Headers are correct size

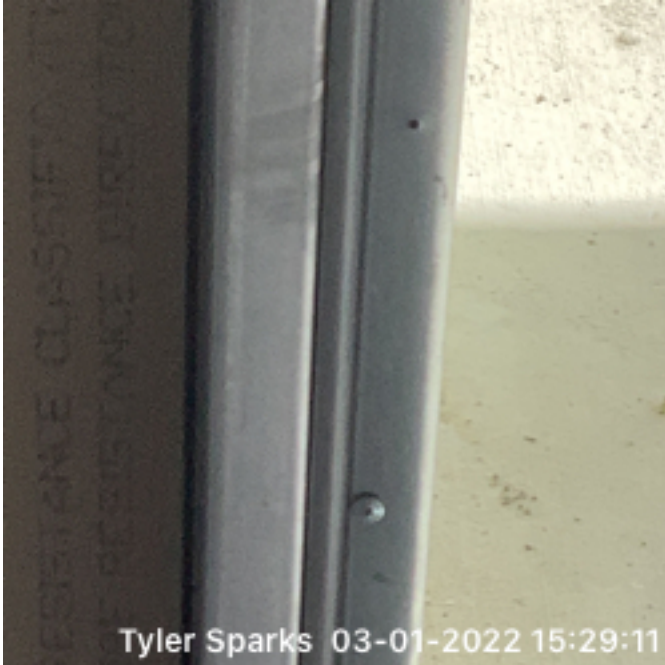
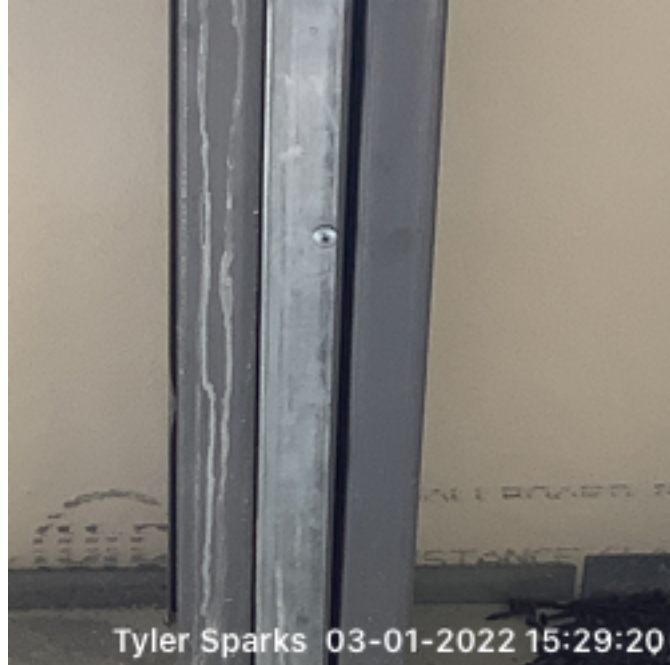
1.01-Post are correct size per plans/code.

S - Satisfactory, the system meets plan/code/manufactures specifications

NOTE: Post are correct size

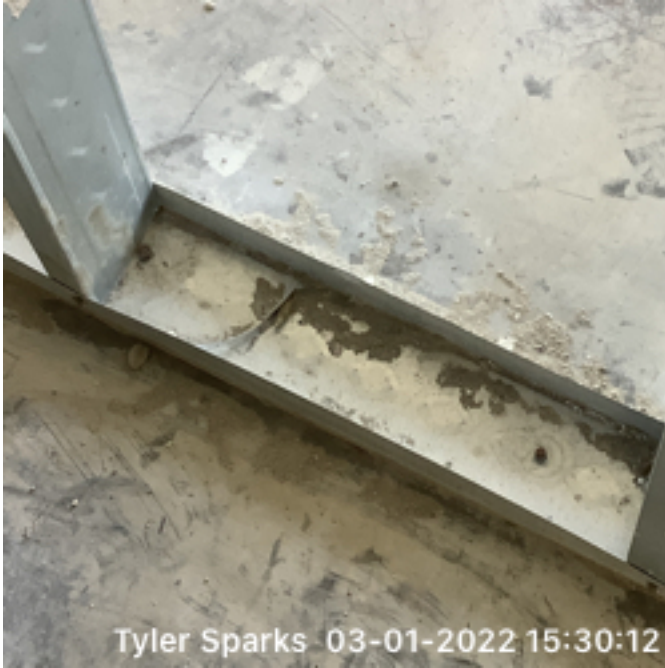
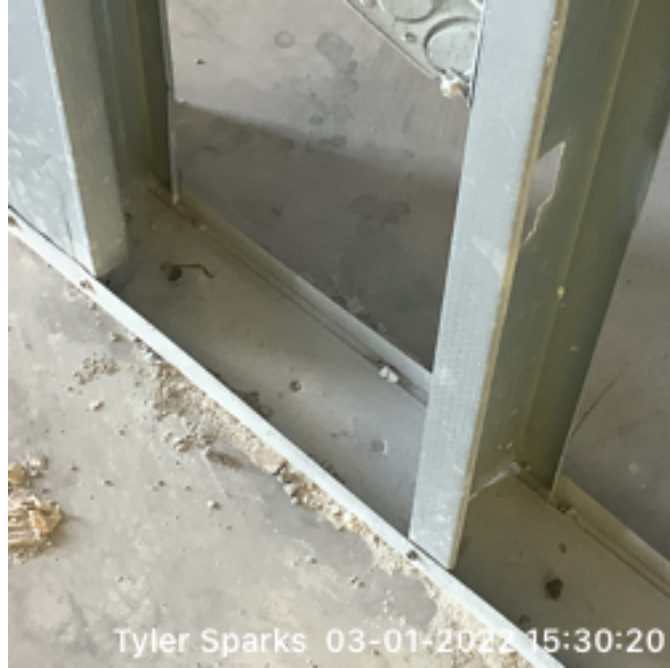
1.04-Anchor bolts are installed per plans/code.

S - Satisfactory, the system meets plan/code/manufactures specifications

NOTE: Pin shot

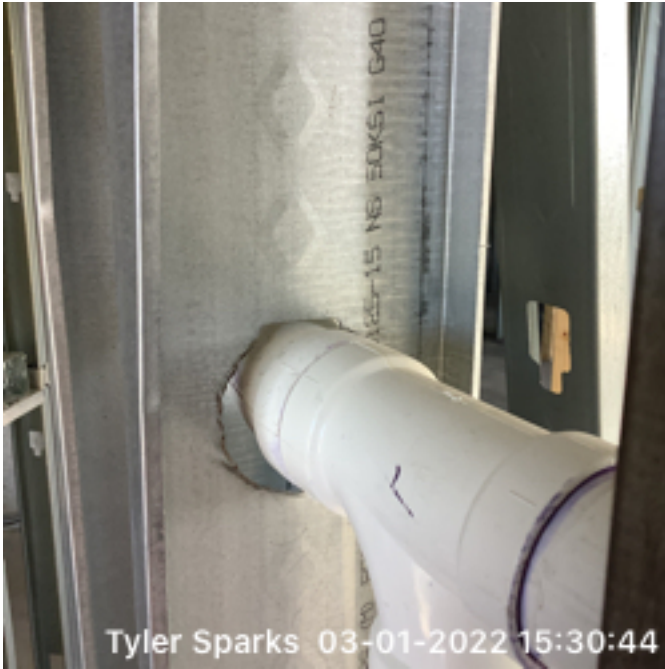
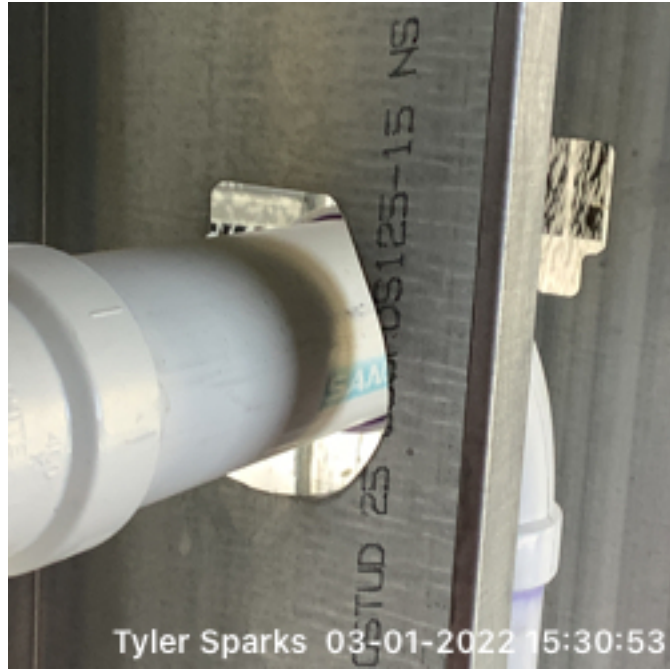
1.06-Wall framing components have not been over notched or drilled.

S - Satisfactory, the system meets plan/code/manufactures specifications

NOTE: Wall framing is not over notched or drilled

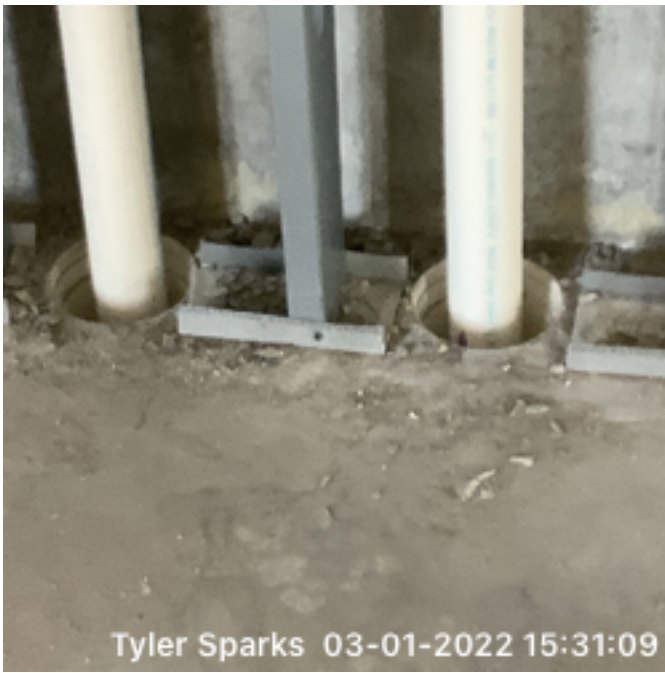
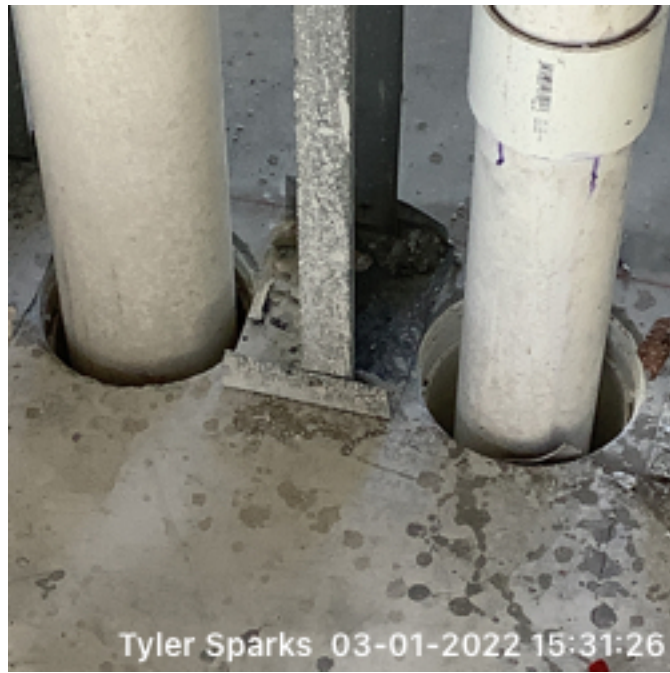
1.07-Floor framing components have not been over notched or drilled.

S - Satisfactory, the system meets plan/code/manufactures specifications

NOTE: Floor framing is not over notched or drilled

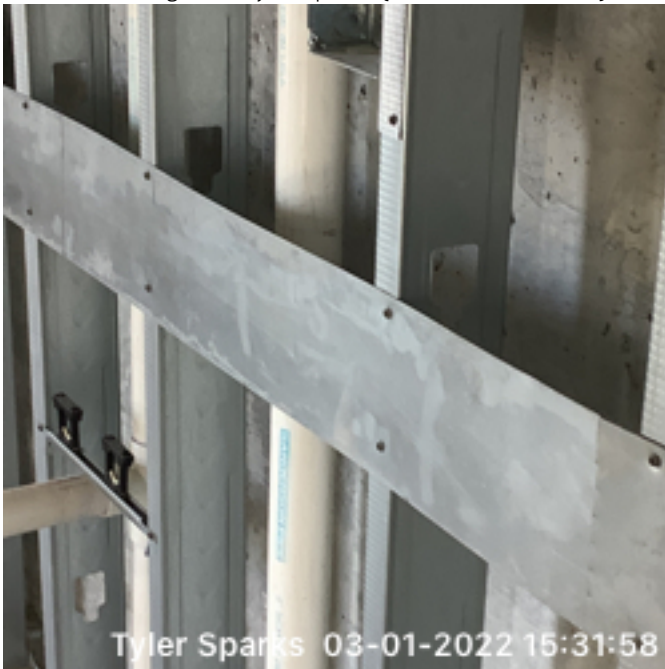
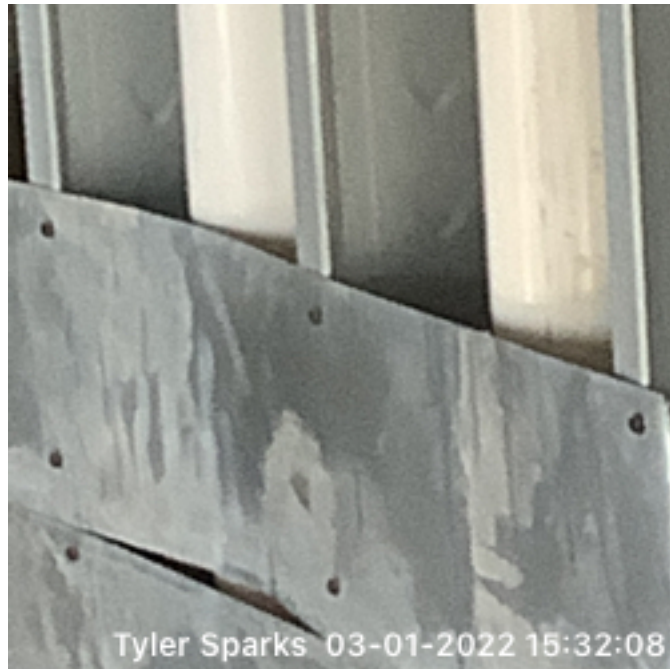
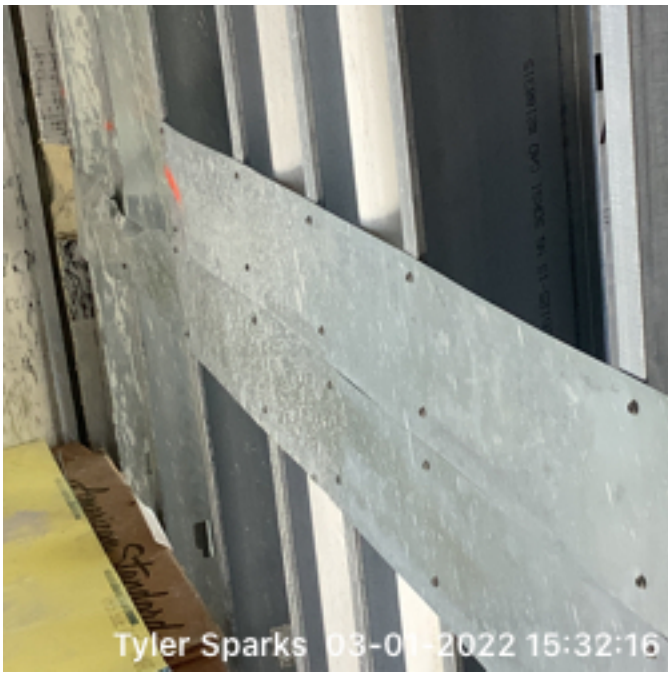
2.03-Interior backing has been installed for railing, plumbing and/or electrical items.

S - Satisfactory, the system meets plan/code/manufactures specifications

NOTE: Interior backing is installed properly
