River Fly- In Condominium
 Unit: 302

Report By: Tyler Sparks

12/09/2021

Framing

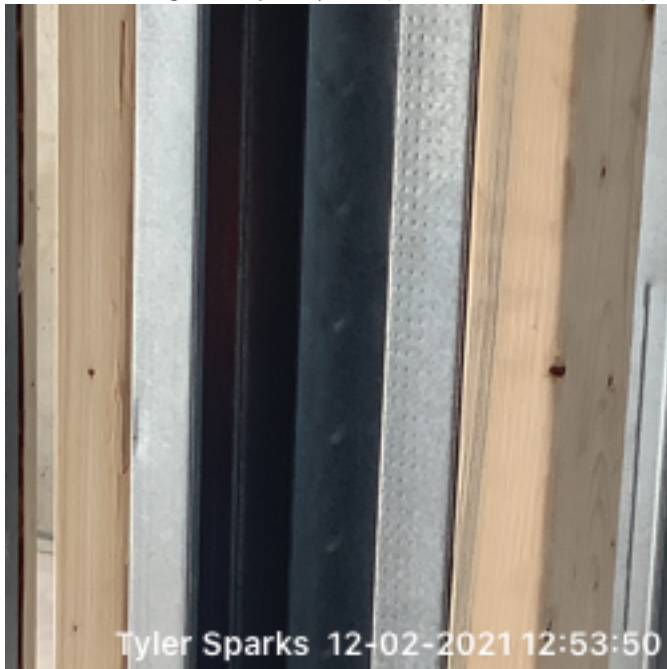
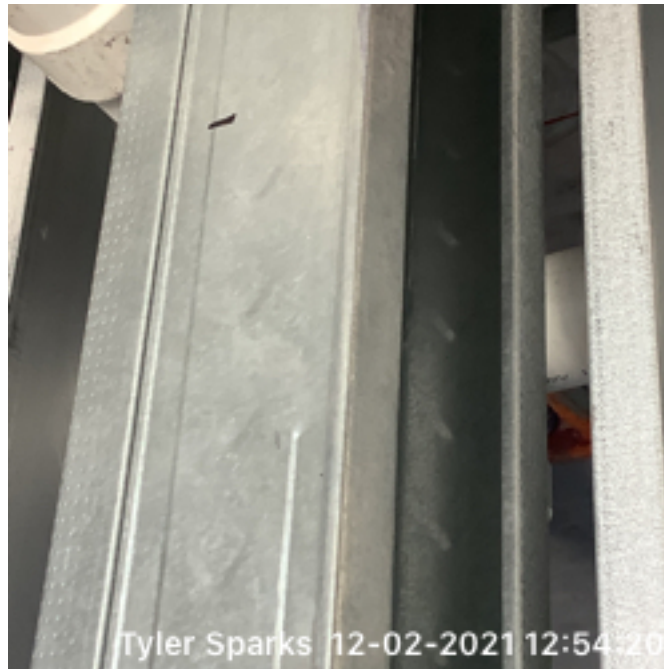
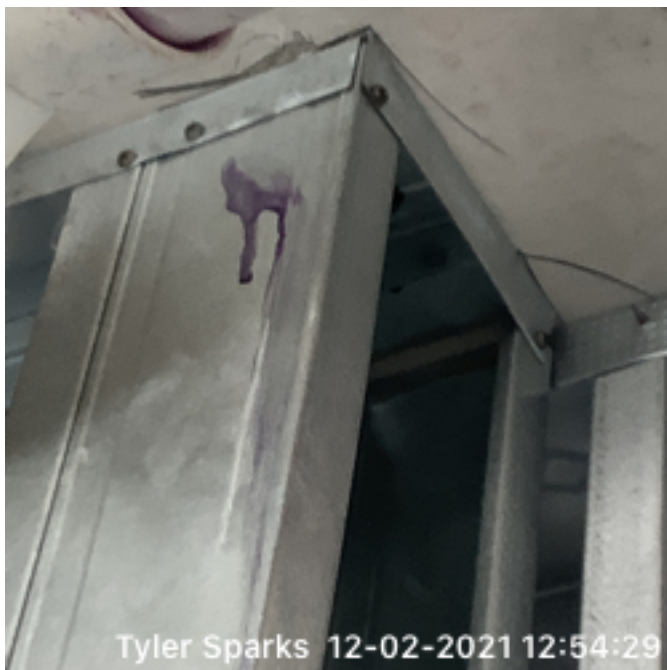
1.01-Post are correct size per plans/code.

S - Satisfactory, the system meets plan/code/manufactures specifications

NOTE: Post are correct size

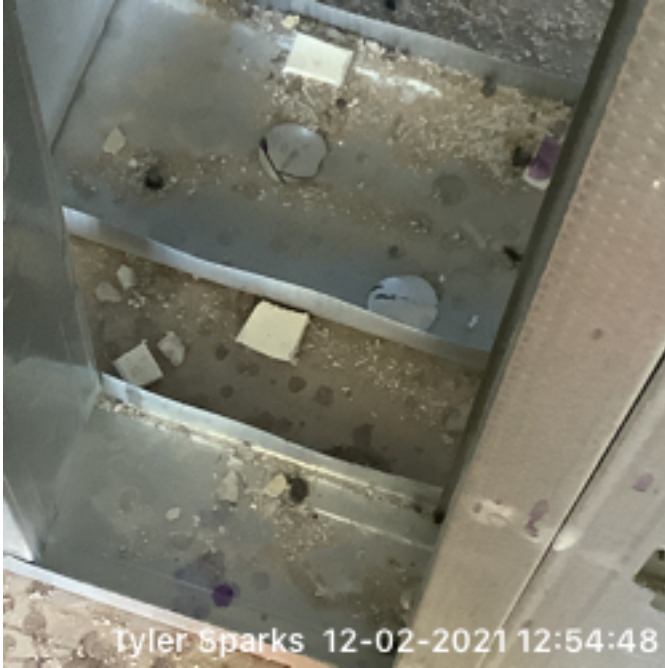
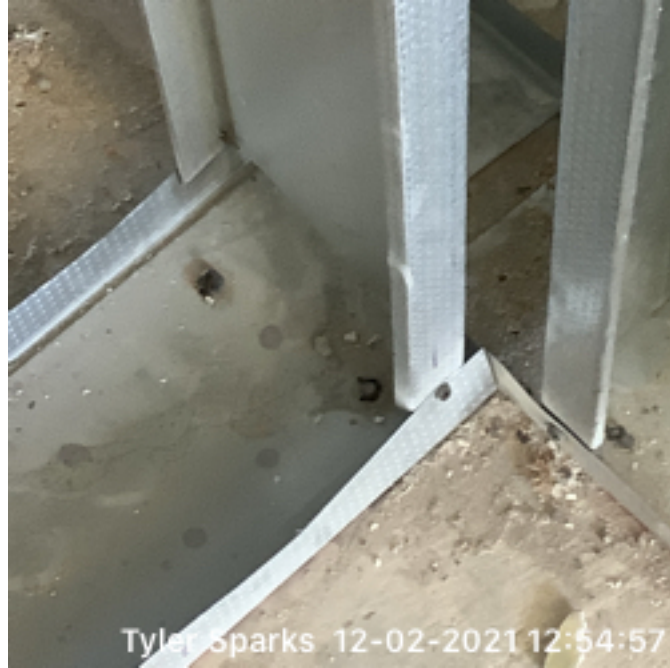
1.04-Anchor bolts are installed per plans/code.

S - Satisfactory, the system meets plan/code/manufactures specifications

NOTE: Pin shot

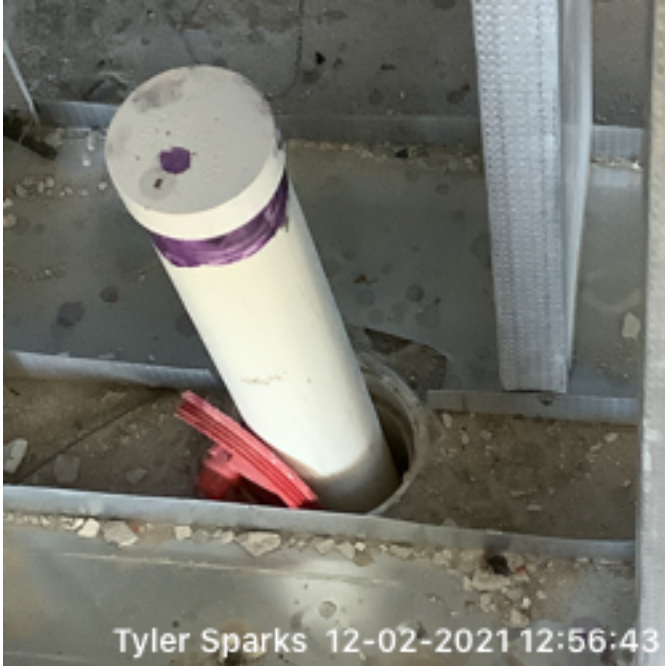
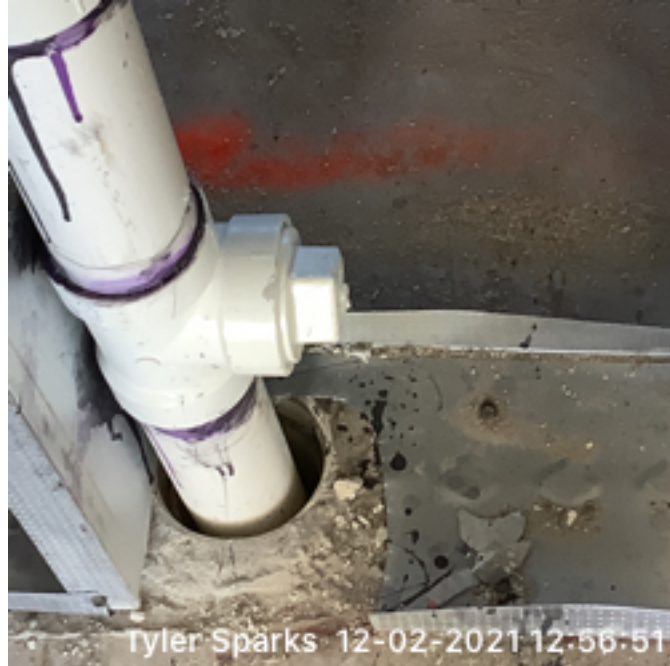
1.07-Floor framing components have not been over notched or drilled.

S - Satisfactory, the system meets plan/code/manufactures specifications

NOTE: Floor framing is not over notched or drilled

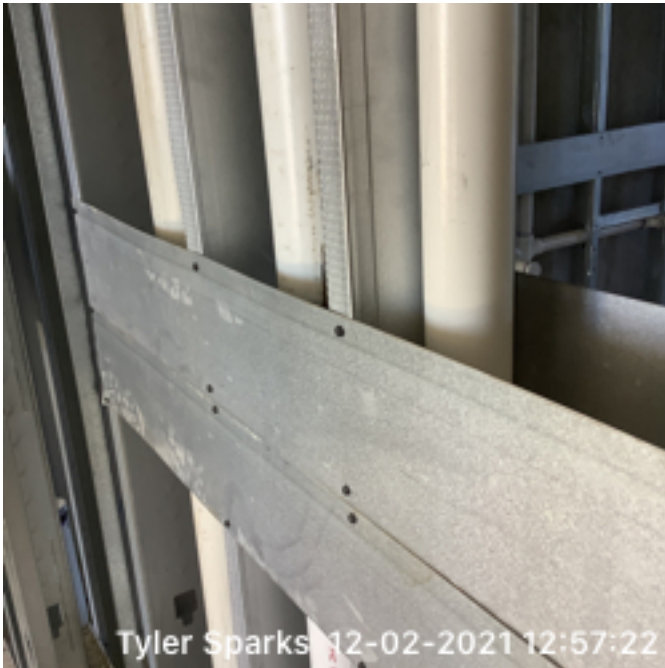
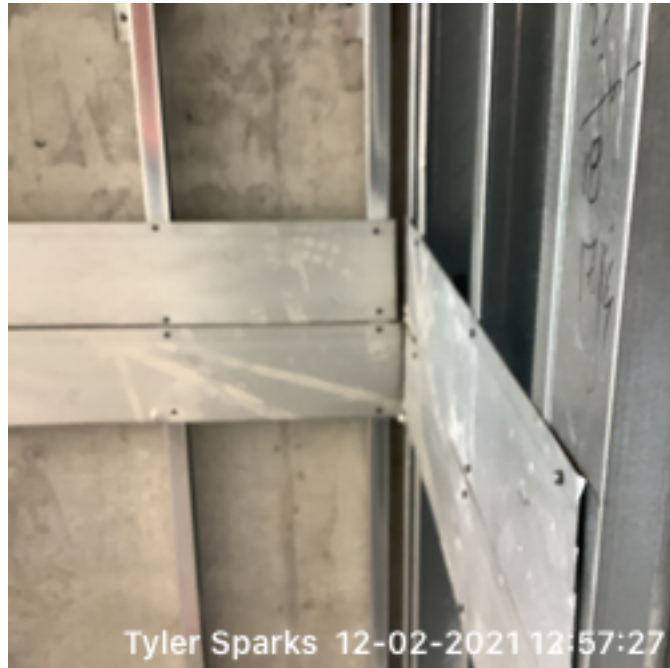
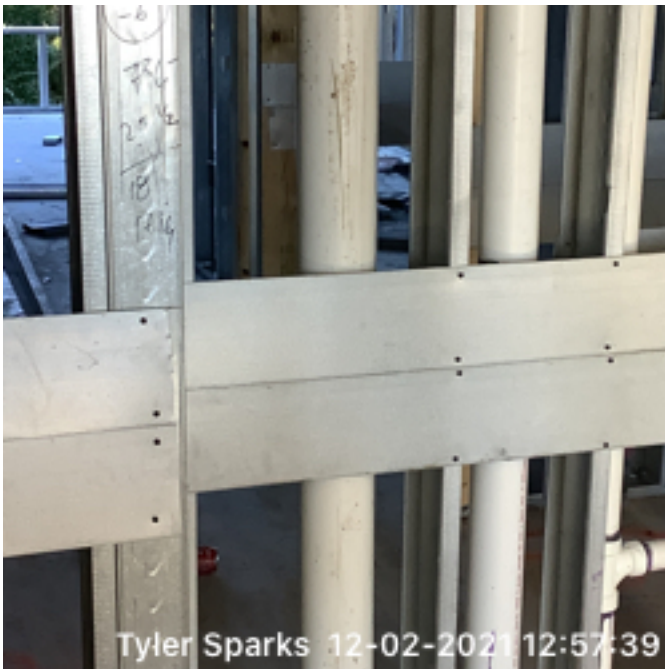
2.03-Interior backing has been installed for railing, plumbing and/or electrical items.

S - Satisfactory, the system meets plan/code/manufactures specifications

NOTE: Interior backing has been installed properly
